—
International Operations & Maintenance Conference in the Arab Countries

19, 20, 21 NOV 2019

▶▶ **Tower Leg Foundation
Corrosion Causes and
Solutions**

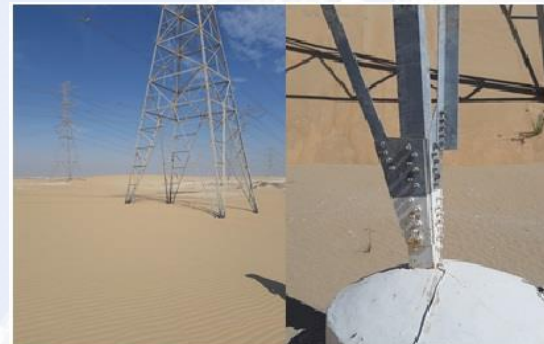
(GCC) countries' climate conditions cause sand movements through the whole year and create sand dunes in these lines middle span and structure pad. Sand accumulation on towers legs will corrode stup angle. Hence, this will affect the network reliability and decrease the foundations service time.

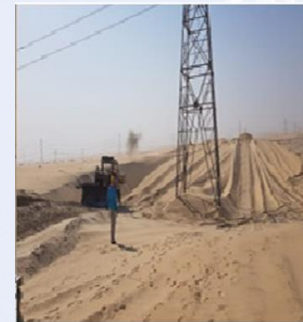
One of routine operation and maintenance duties for GCC countries is implementing sand removal activities throughout the year for accumulated sand on access road and structure pad and this kind of work repetitive and very costly. On other hand repair and rehabilitation rusty stop angles that effects by sand accumulation on towers foundations however corrosion will not stop and loses thickness of affected tower members

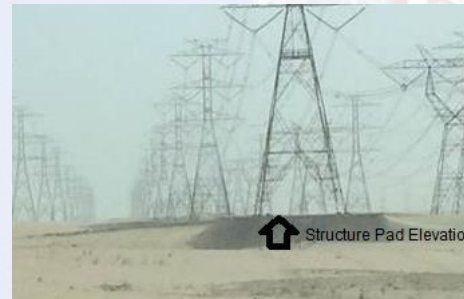
The structure pad level must be upper than sand within radius from the edge of structure pad. The minimum height of structure pad must be 1.5m on Sabkah area or sand encroachment area in order to protect the wearing surface from detrimental effects of capillary movement of the ground water and erosion [4]. Protect structure pad with rip rap in areas flooded with water
