المؤتمر الدولي الثاني والعشرون لإدارة الأصول والمرافق والصيانة
The 22nd International Asset, Facility & Maintenance
Management Conference

Online Insulation Monitoring Technology

A Real-time Insulation Monitoring Solution

TSNL-2000™ Online Insulation Safety Analysis System

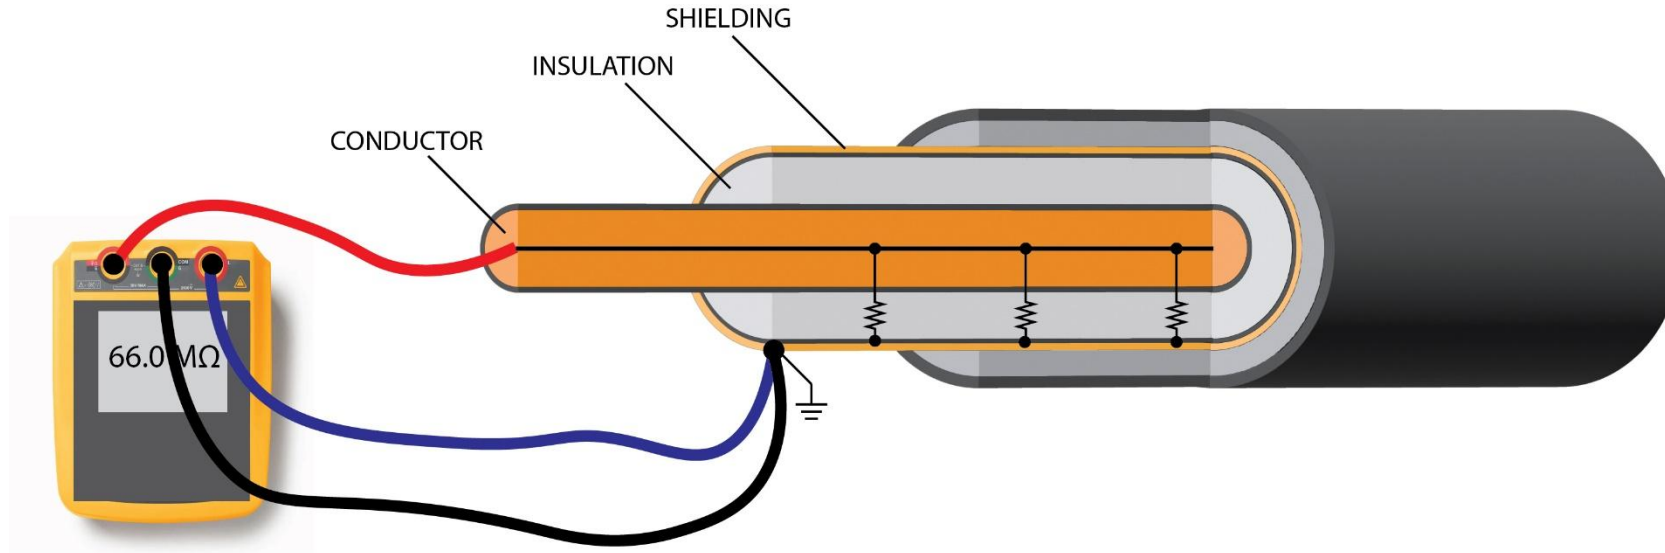
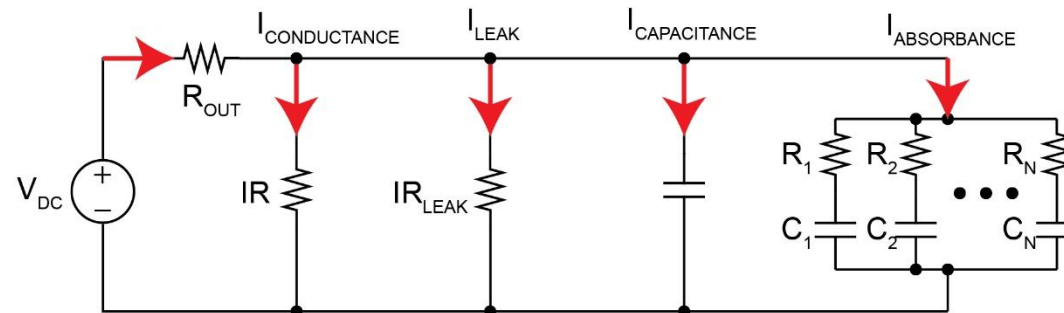
Conventional Insulation Resistance Measurement

IR measurement per IEEE

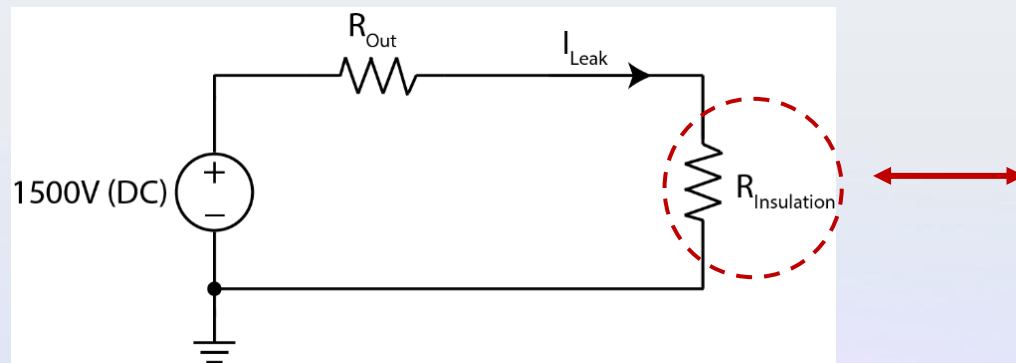
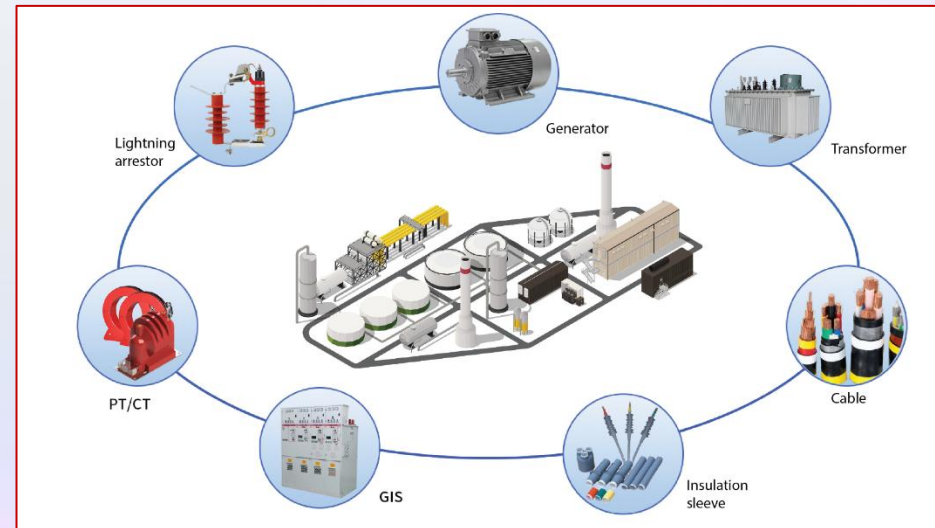
Equivalent Circuit

TSNL-2000 Insulation Resistance Measurement

$$R_{Insulation} = \frac{1500V}{I_{Leak}} - R_{out}$$

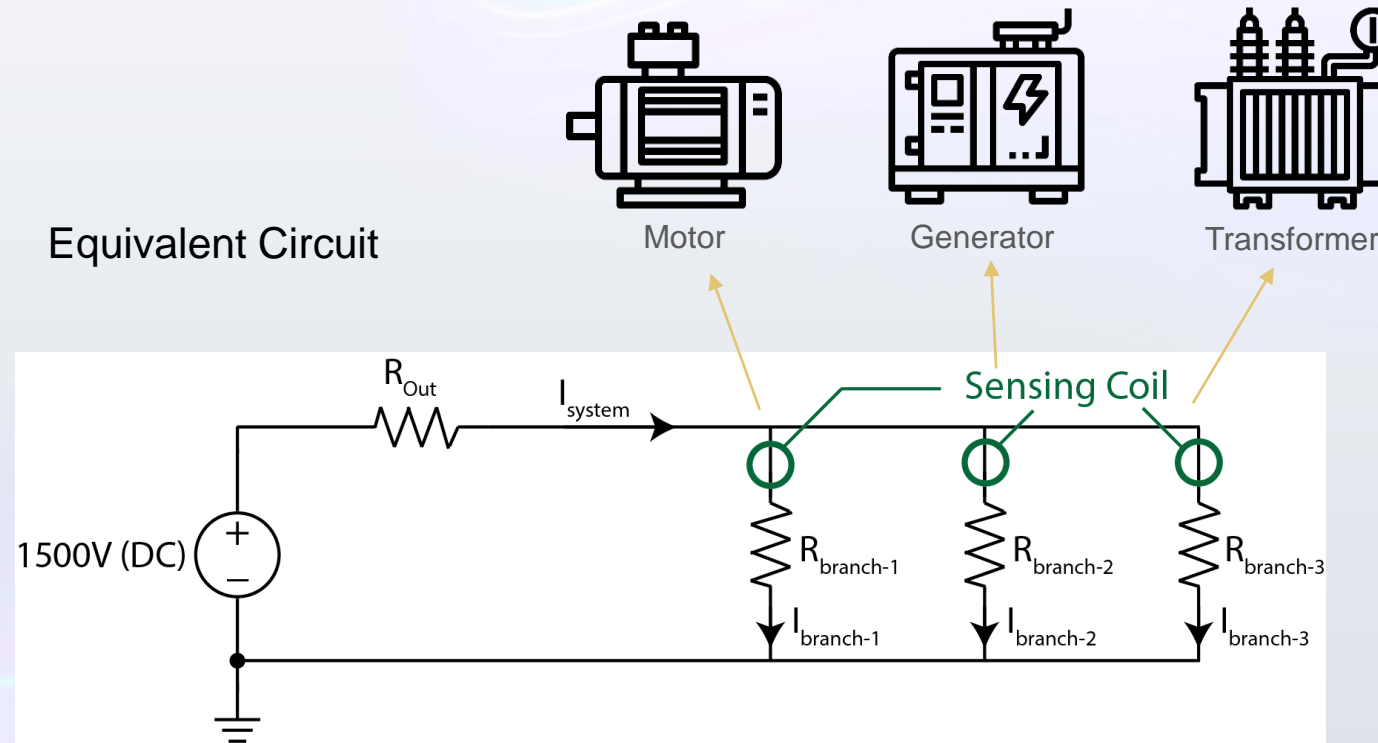
TSNL-2000 Insulation Resistance Measurement

$$R_{Insulation} = \frac{1500V}{I_{Leak}} - R_{Out}$$

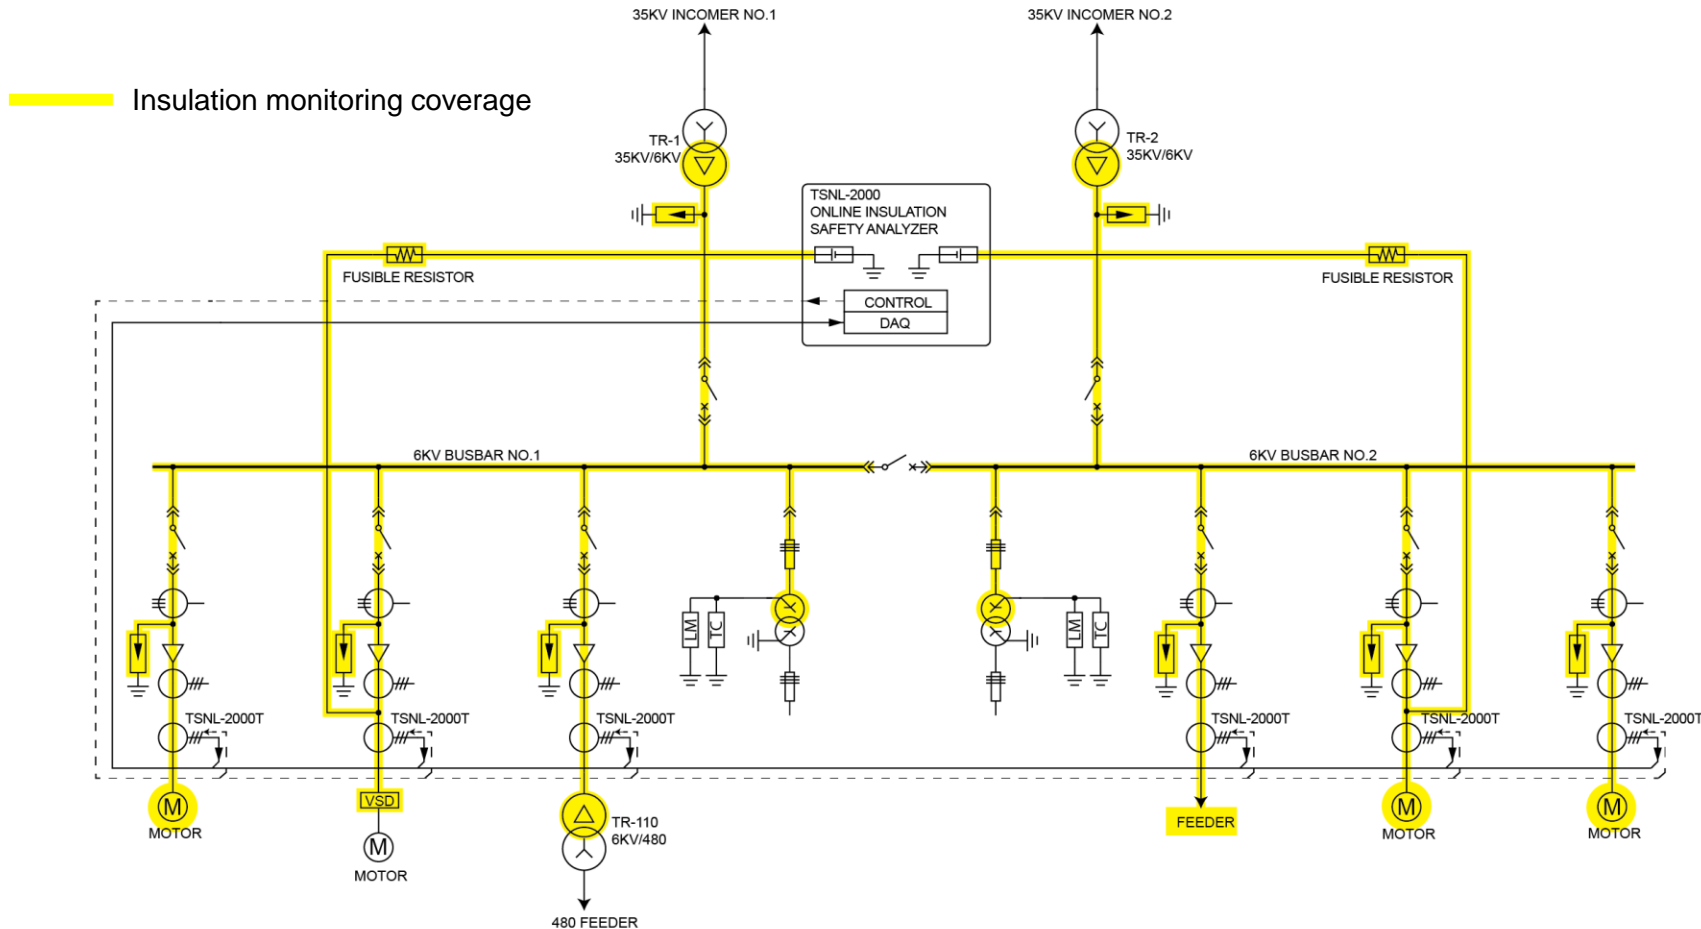
TSNL-2000 IMPLEMENTATION EXAMPLE
35 KV / 6 KV SUBSTATION UNGROUNDED

Application example—grounded through NGR / ASC system

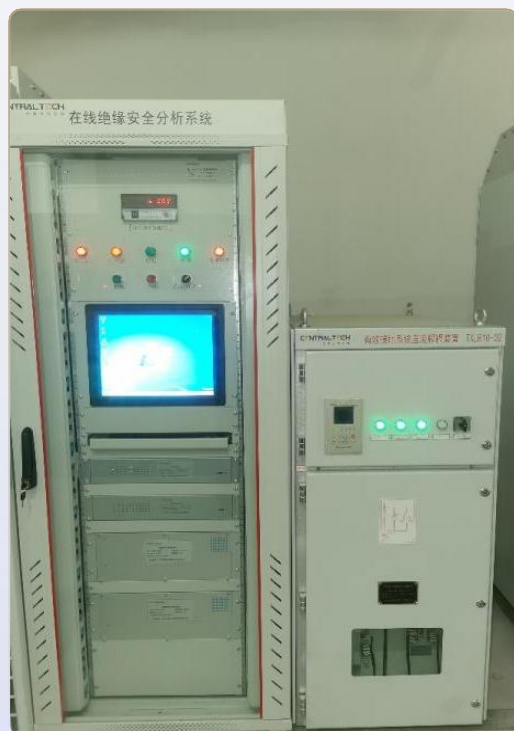
TSNL-2000 panel (left)
TXLR panel (right)

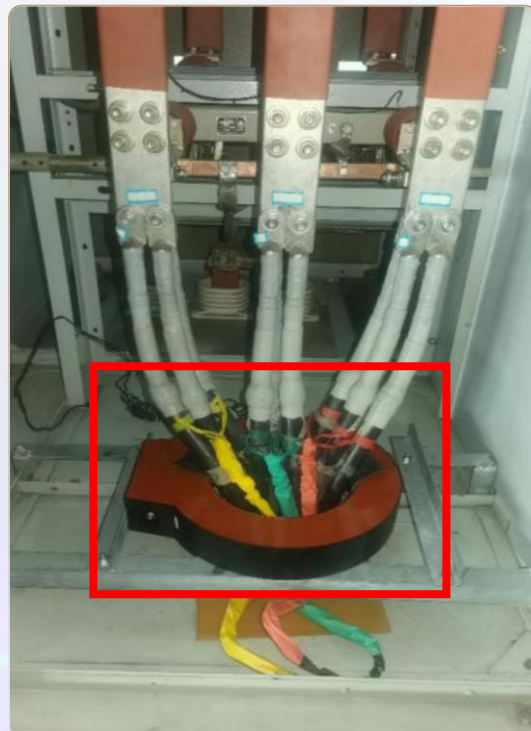
TSNL-2000T current
sensor

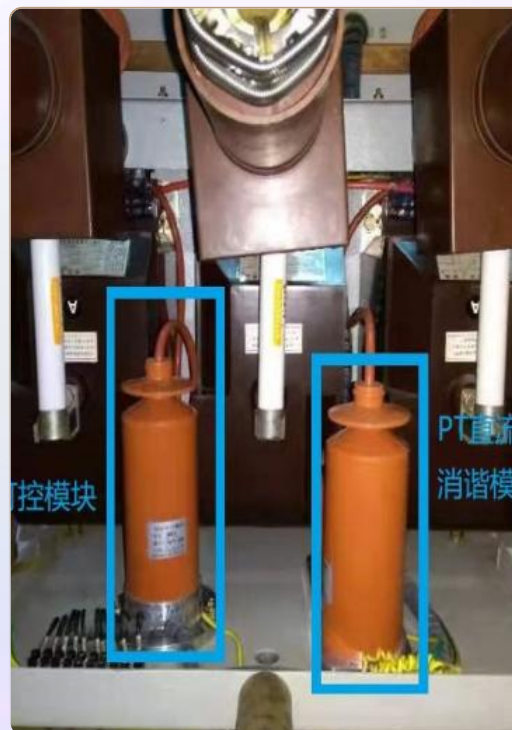
PT-type modules
LMCU (left)
TCDH (right)

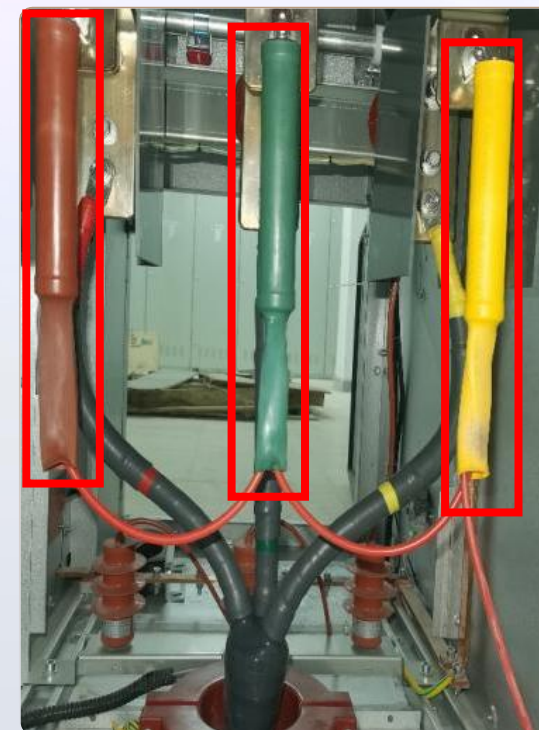
Fusible Resistors

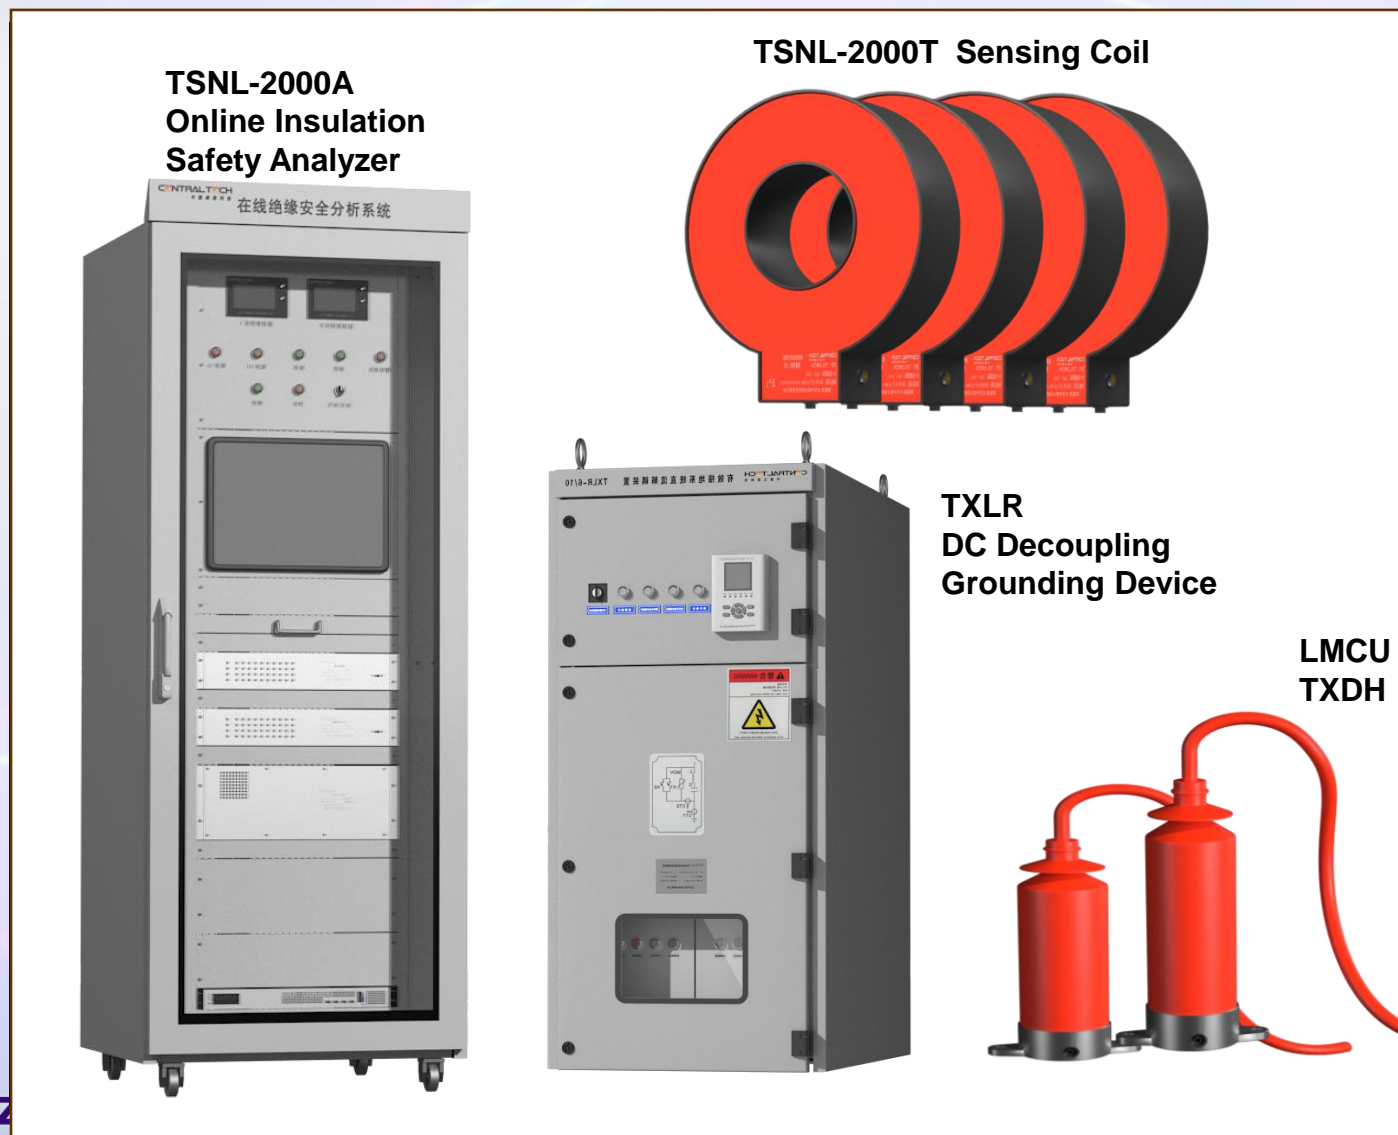
TSNL-2000 Specifications

Item	Parameters
Working Power Supply	AC220V-10%, +15%; DC220V-5%, +7%
Rated Power	DC800W, AC800W
Ambient Temperature and Relative Humidity	-10°C-40°C, ≤95%
Measuring Voltage	DC1500V
Insulation Measurement Range	0-200MΩ
Number of Measuring Circuits	4 circuits - 32 circuits/side
Effective DC Current Measurement Range	5μA-1mA
Resistance Resolution	0.1MΩ
DC Current Measurement Precision	Class 5 (error < 5%)
Insulation Resistance Error	< ±3%
Alarm Resistance Setting	1-99 (MΩ) panel setting
Inner Diameter of High-Precision Current Sensor	130 mm, 200 mm, 300mm;
Communication	RS-485, IEC-104 ZIGBEE protocols

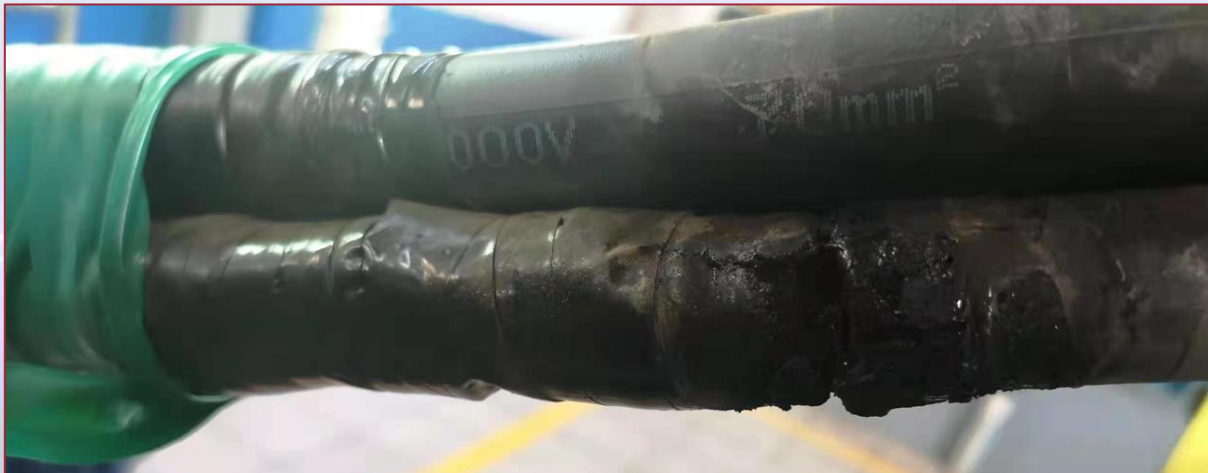
Insulation hazard: damaged cable joint on 10kV cable.

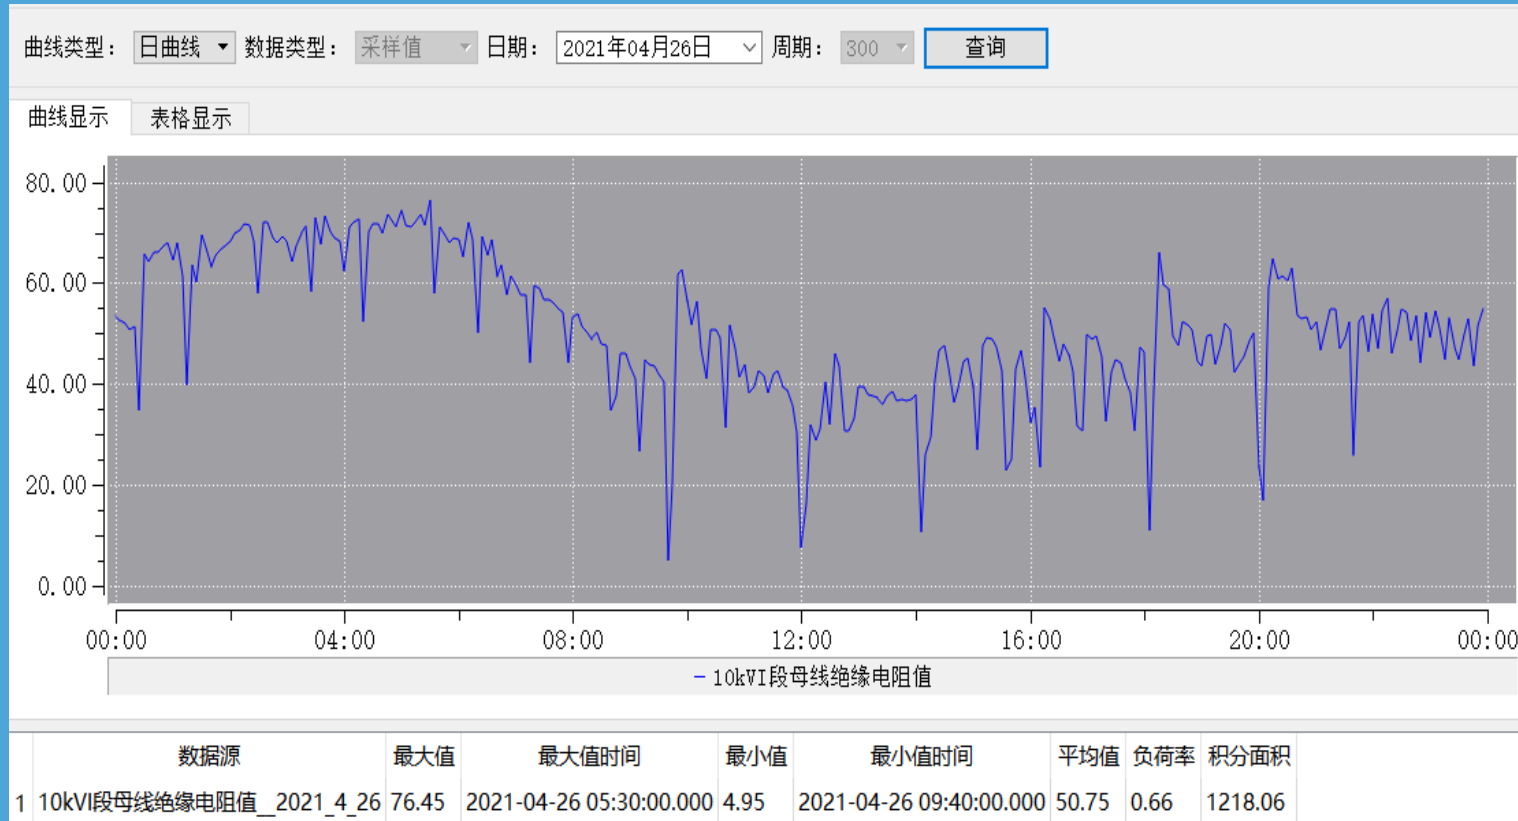
To ensure production continuity, the user closely monitored the system's insulation resistance.

From April 21 to April 26, the insulation resistance continued to show abnormal fluctuations.

The lowest insulation resistance value reached **4.95 MΩ**, which is below the standard threshold, indicating that the system's insulation was on the verge of failure.

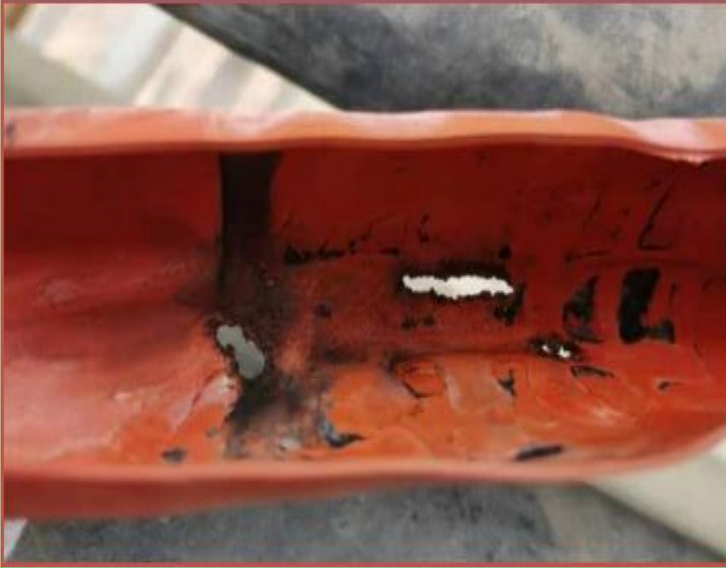
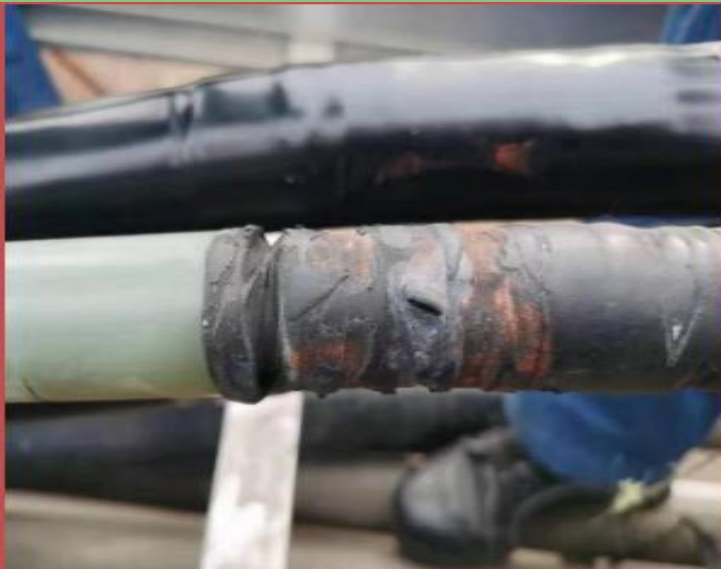
April 29, the user completed the production task.

April 30, the user conducted an inspection of this 10kV system.

It was determined that **water had entered the cable middle joint** due to damage to the outer sheath.

Upon dissecting the cable middle joint, it was found that **corrosion had occurred**, and signs of scorch marks were observed, accompanied by single-phase discharge.

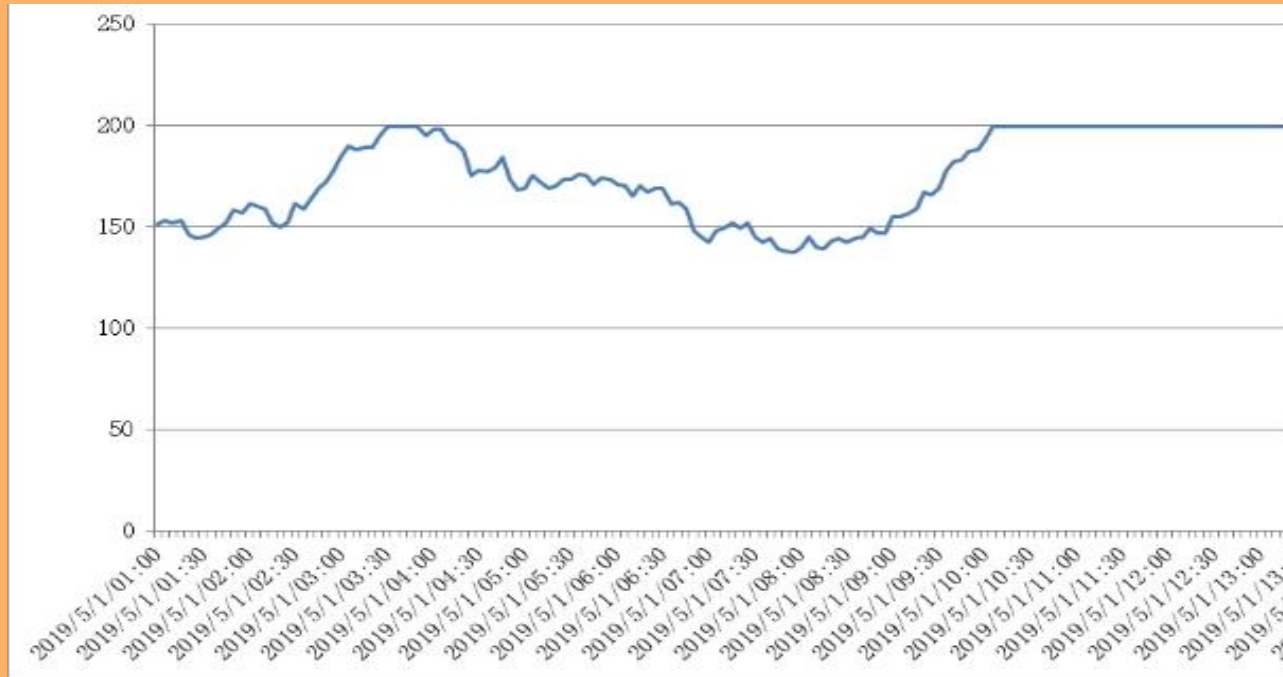
On May 1st, 2019, the operators noticed that the online insulation safety analysis system indicated a **decrease in the insulation resistance of the motor circuit**.

From 1:00 AM to 10:00 AM on that day, the circuit insulation resistance underwent two abnormal periodic decreases, after which the insulation resistance **returned to normal**.

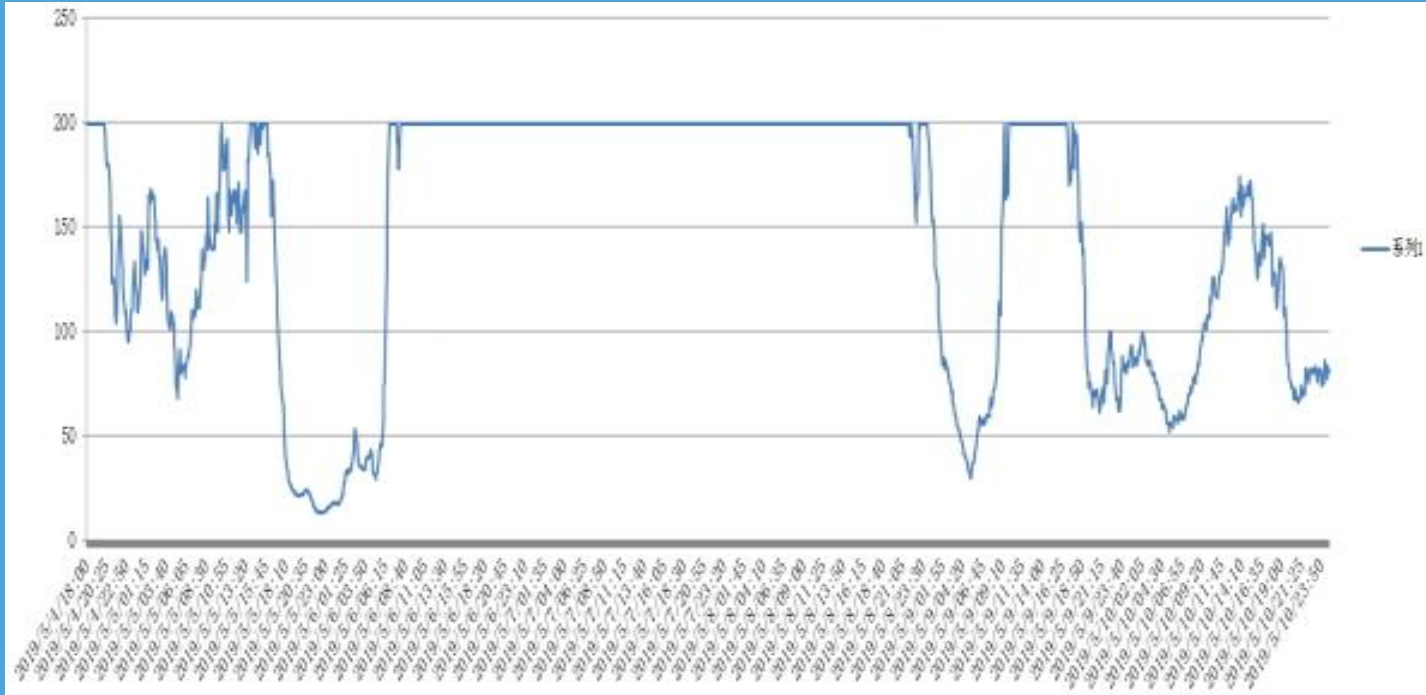
From May 4 to May 10, the insulation resistance exhibited **abnormal frequent fluctuations**, with the lowest value dropping to around **15 MΩ**, and the situation showed a clear worsening trend.

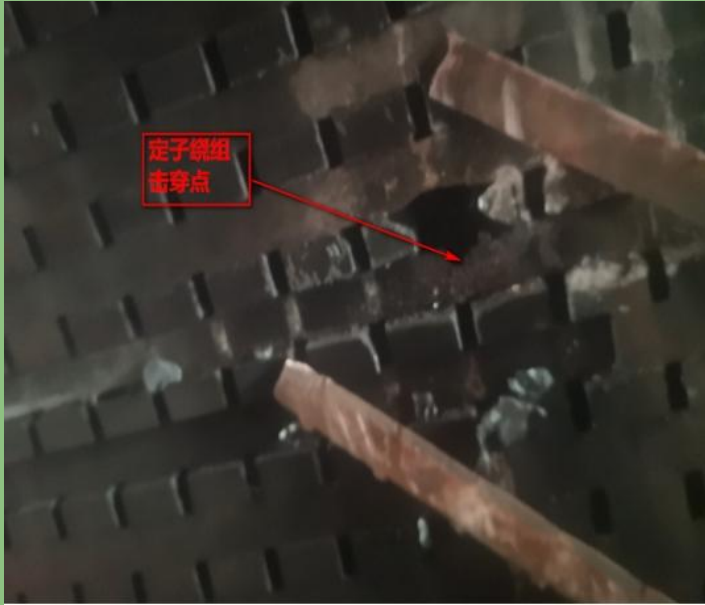
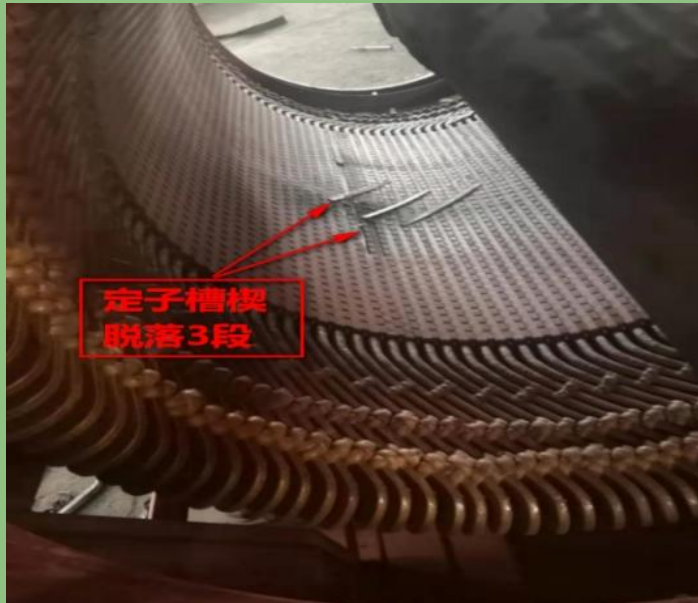
The primary cause of the damage found inside the motor winding is due to manufacturing defects. TSNL-2000 system promptly detected the insulation hazard in the motor's stator windings, prevented an insulation failure, which could have led to a short circuit, arcing, and motor destruction. TSNL-2000 system was effective in diagnosing motor conditions and insulation defects.
